EN Instructions for use / assembly instructions

Talis M54 210 2jet
72800XXX

Talis M54 210 Eco 2jet
72842XXX

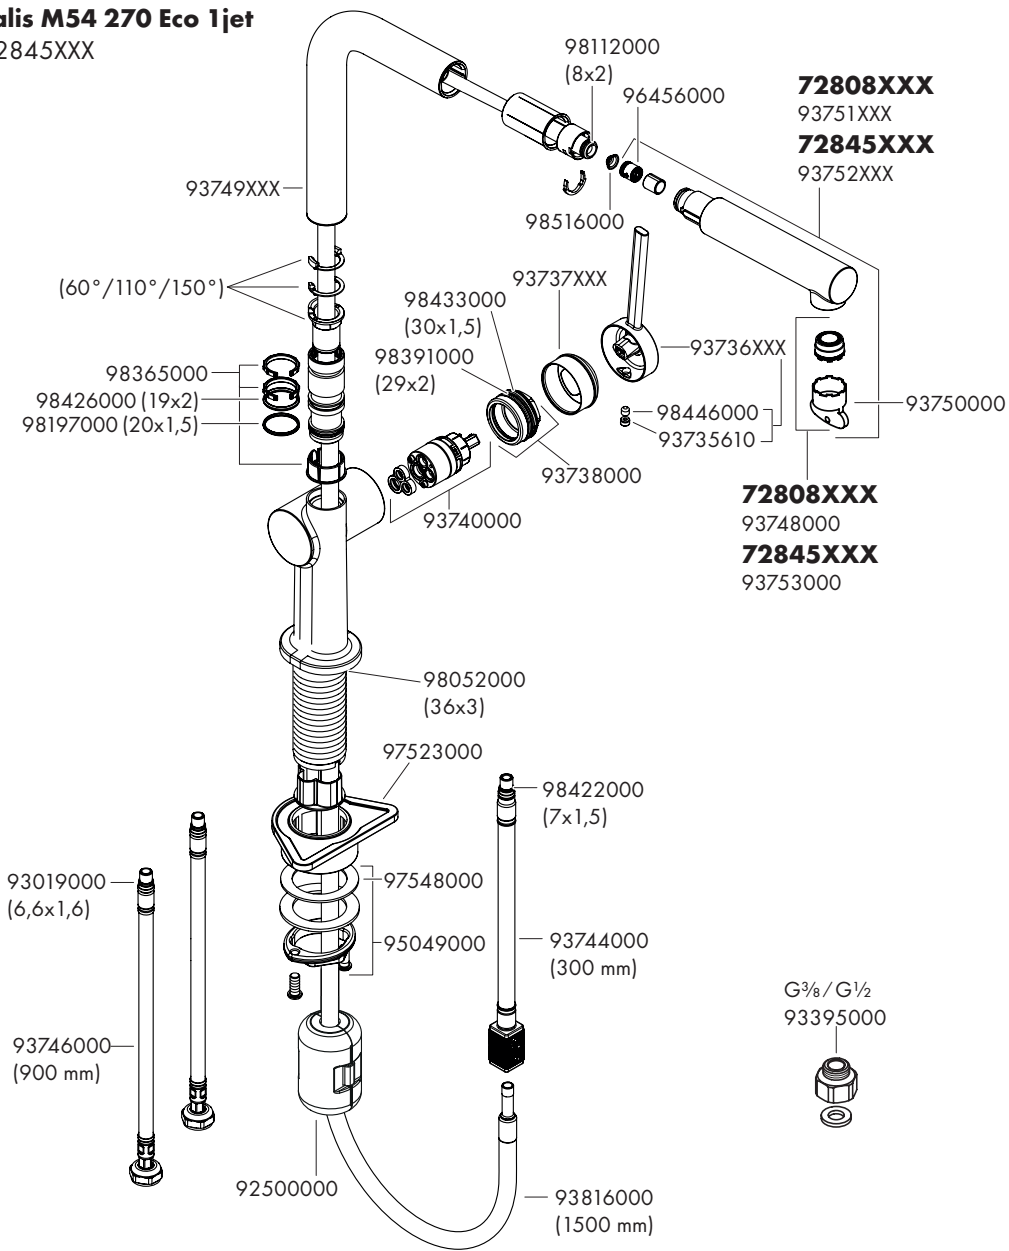
Talis M54 270 1jet

72808XXX

Talis M54 270 Eco 1jet

72845XXX

Spare parts (see page 45)
